Miscellaneous Paper CERC-96-8
December 1996

US Army Corps
of Engineers
Waterways Experiment
Station

Pilot Study to Characterize Ordnance Contamination Within the Sea Bright, New Jersey, Sand Borrow Site

Final report

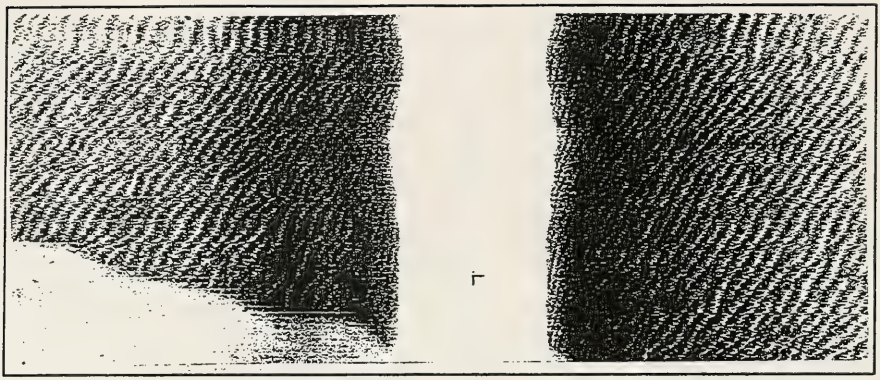
Figure 8. Side-scan sonar record showing sand waves

g. The presence of extensive sand wave zones and other bottom texture evidence observed via the underwater video and the side-scan sonar suggest that the bottom sediments are quite mobile and it is likely that there will have been some scour and burial of bottom siting ordnance (particularly in the northern section of the borrow). However, the finite magnetometer data collected and analyzed during this study suggest that most of the ordnance-like targets are at or close to the sand surface and appear to be mobile, having oriented themselves parallel to the predominate wave crests.

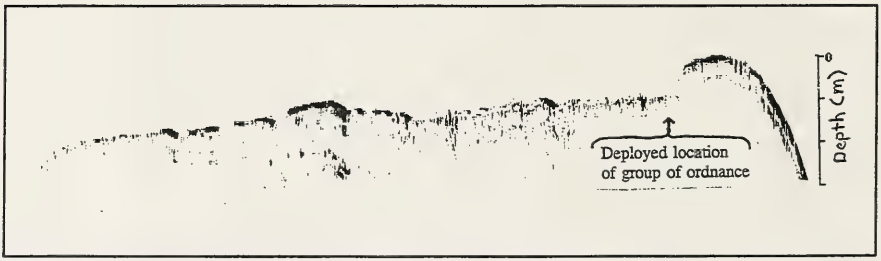
prospective site clean-up activities. As the first step in testing the X-star, it was towed several times approximately 1 to 2 m above the inert ordnance test bed. Targets were detected which may be interpreted as representing the ordnance located on the bottom (Figure 9); however, nothing could be detected at the location of the single buried piece or at the buried cluster. Since a return from the buried ordnance could not be detected, we conclude that the scattering of the acoustical signal by the sandy sediment prohibits the use of X-star to identify buried ordnance targets in this setting. The X-star was towed along a number of lines in the survey area and throughout the record there were target returns from the bottom surface similar to those observed in the test bed at the Coast Guard Station. There were some subsurface targets noted in the tows from the borrow area, but the nature of these returns could not be used to verify if they were or were not ordnance. The acoustical return from the X-star cannot be used to discriminate between objects of different composition. Thus, the observed returns could be stones, wood, or ordnance. The conclusion of the pilot study is that X-star would be of limited use during the conduct of a full-scale survey.

Figure 9. X-star record from along line of ordnance placed for test of system

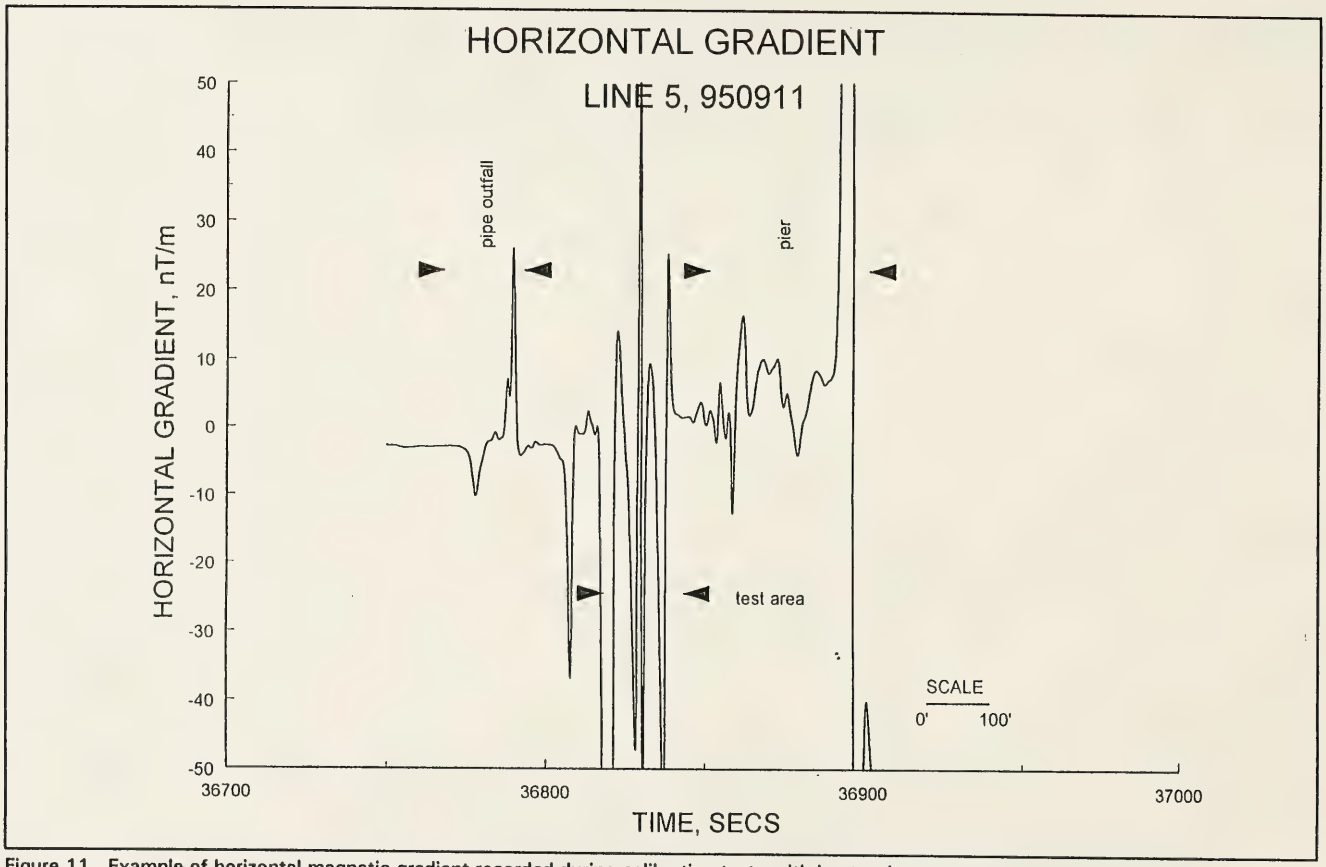
test site, Figures 11 and 12. In most tests the signature of adjacent items overlapped, since the area of magnetic disturbance well exceeded 3 m. However, it was still possible to distinguish the individual presence of seven to nine items from the magnetic gradient data in every instrument pass through the test area.

Figure 11. Example of horizontal magnetic gradient recorded during calibration tests with inert ordnance test targets, pass number 5

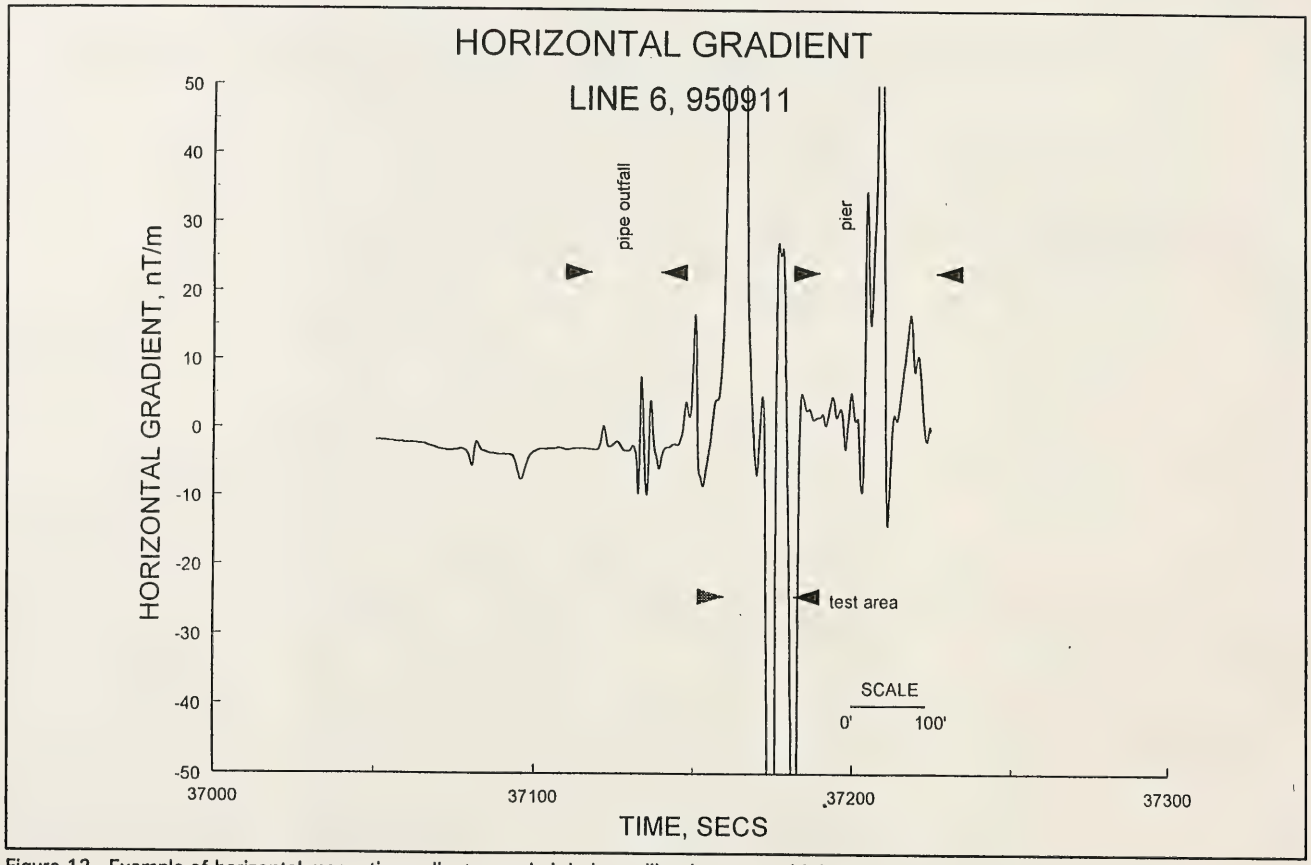
Figure 12. Example of horizontal magnetic gradient recorded during calibration tests with inert ordnance test targets, pass number 6

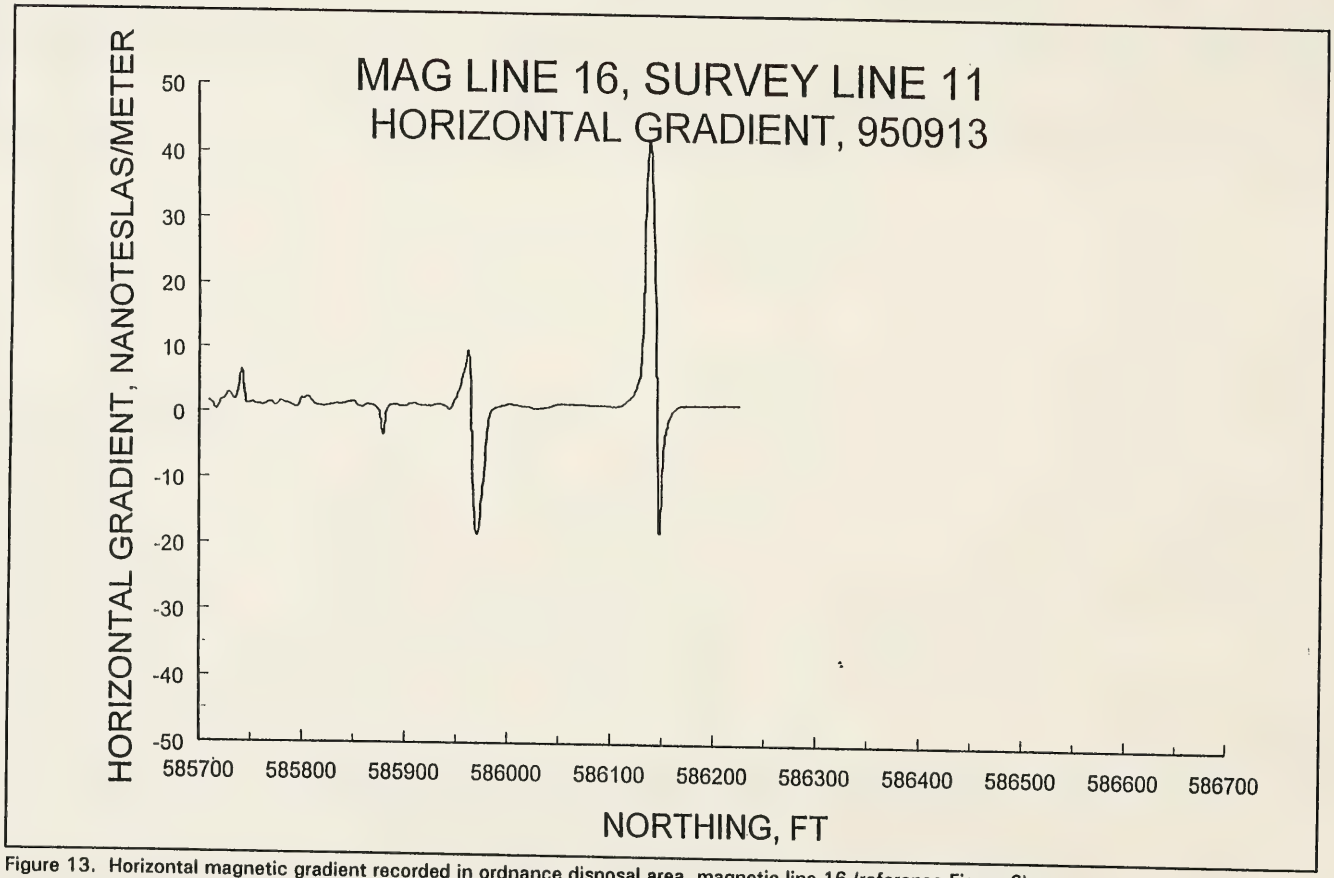
Figure 13. Horizontal magnetic gradient recorded in ordnance disposal area, magnetic line 16 (reference Figure 6)

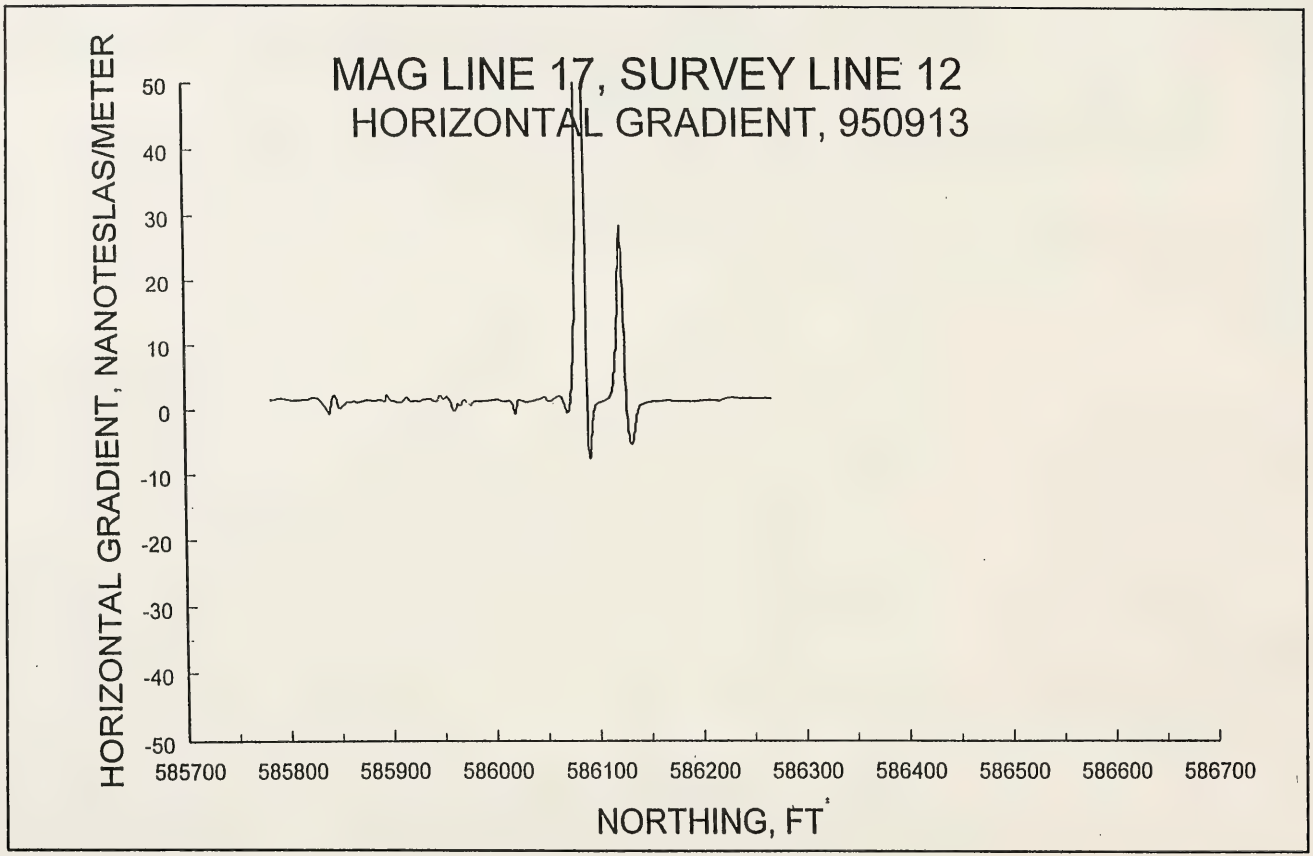
Figure 14. Horizontal magnetic gradient recorded in ordnance disposal area, magnetic line 17

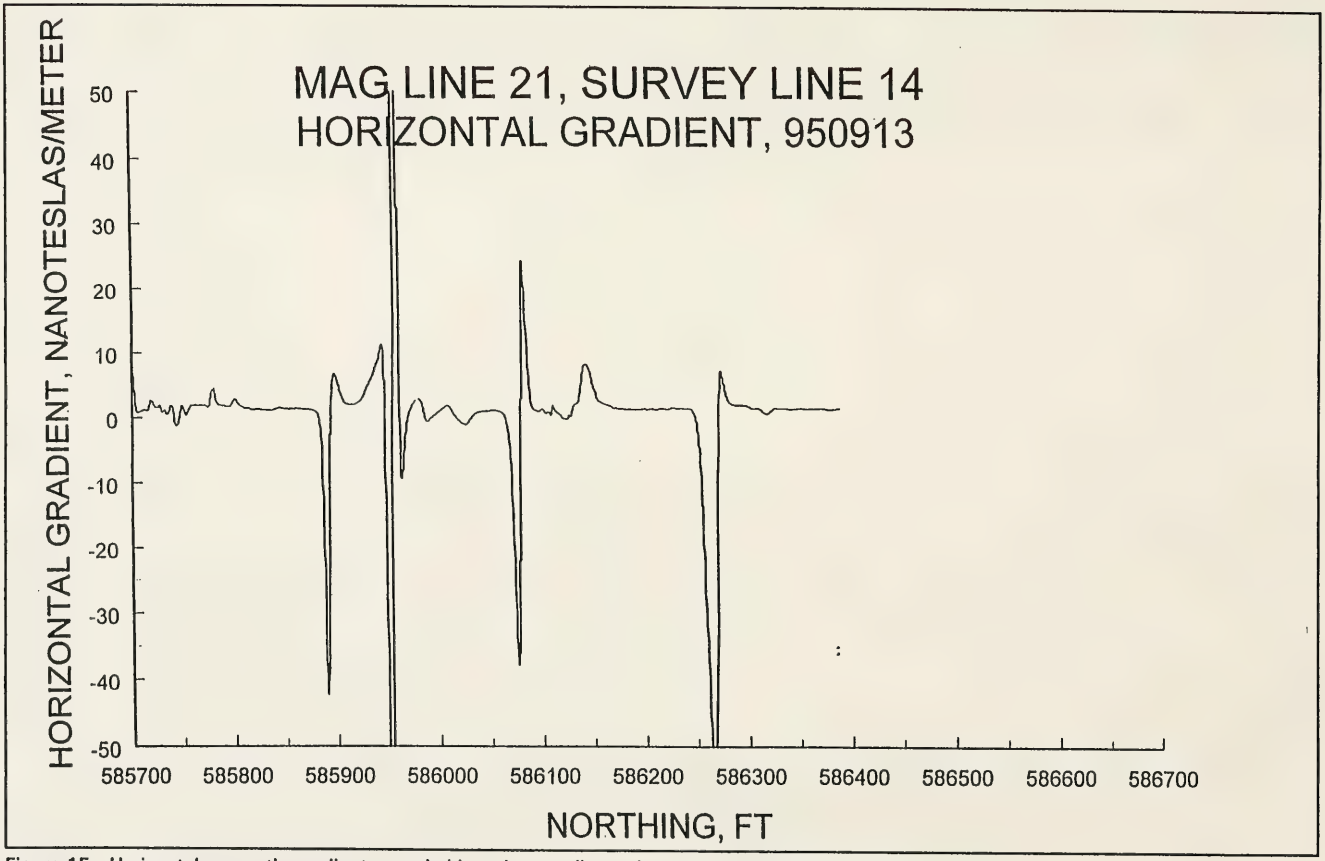
Figure 15. Horizontal magnetic gradient recorded in ordnance disposal area, magnetic line 21

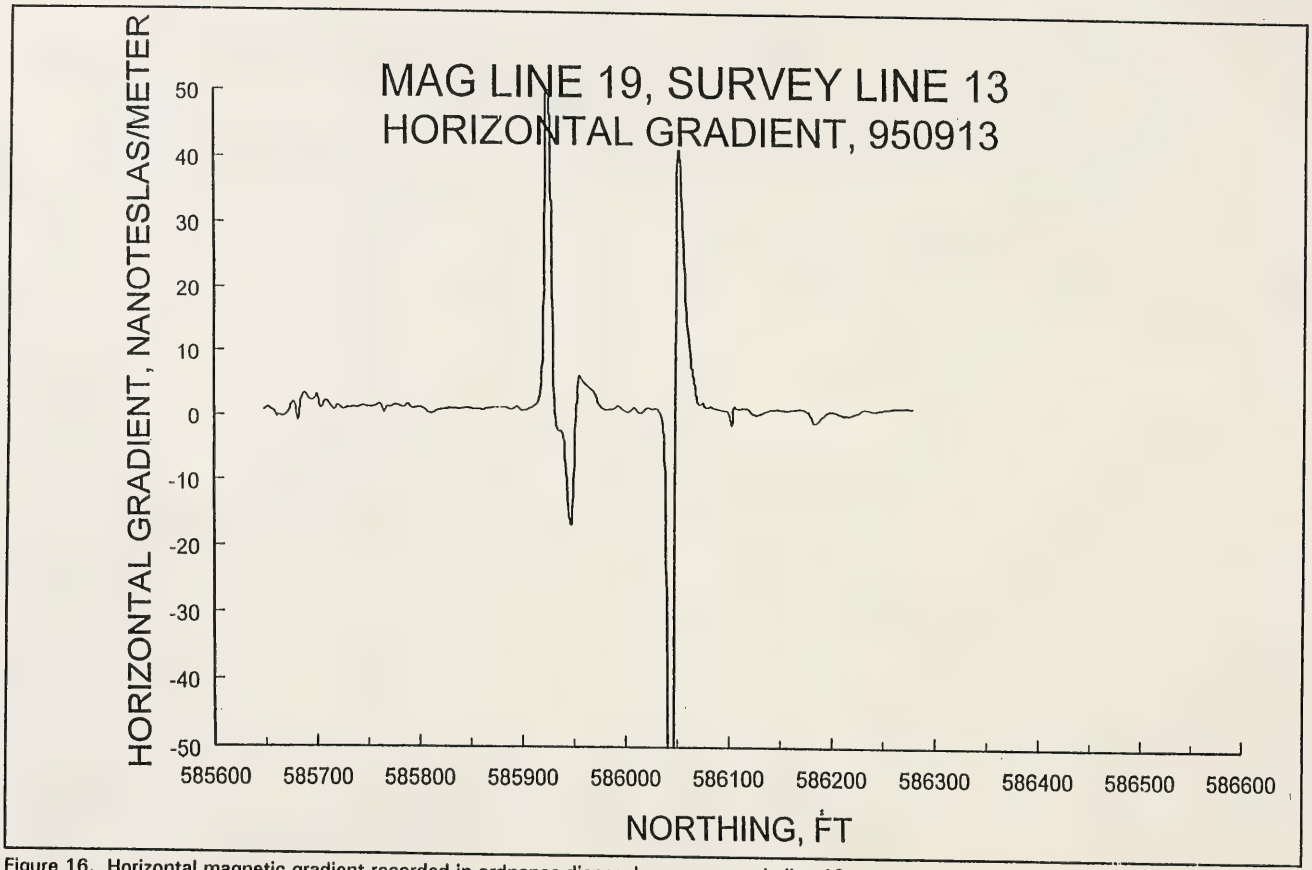
Figure 16. Horizontal magnetic gradient recorded in ordnance disposal area, magnetic line 19

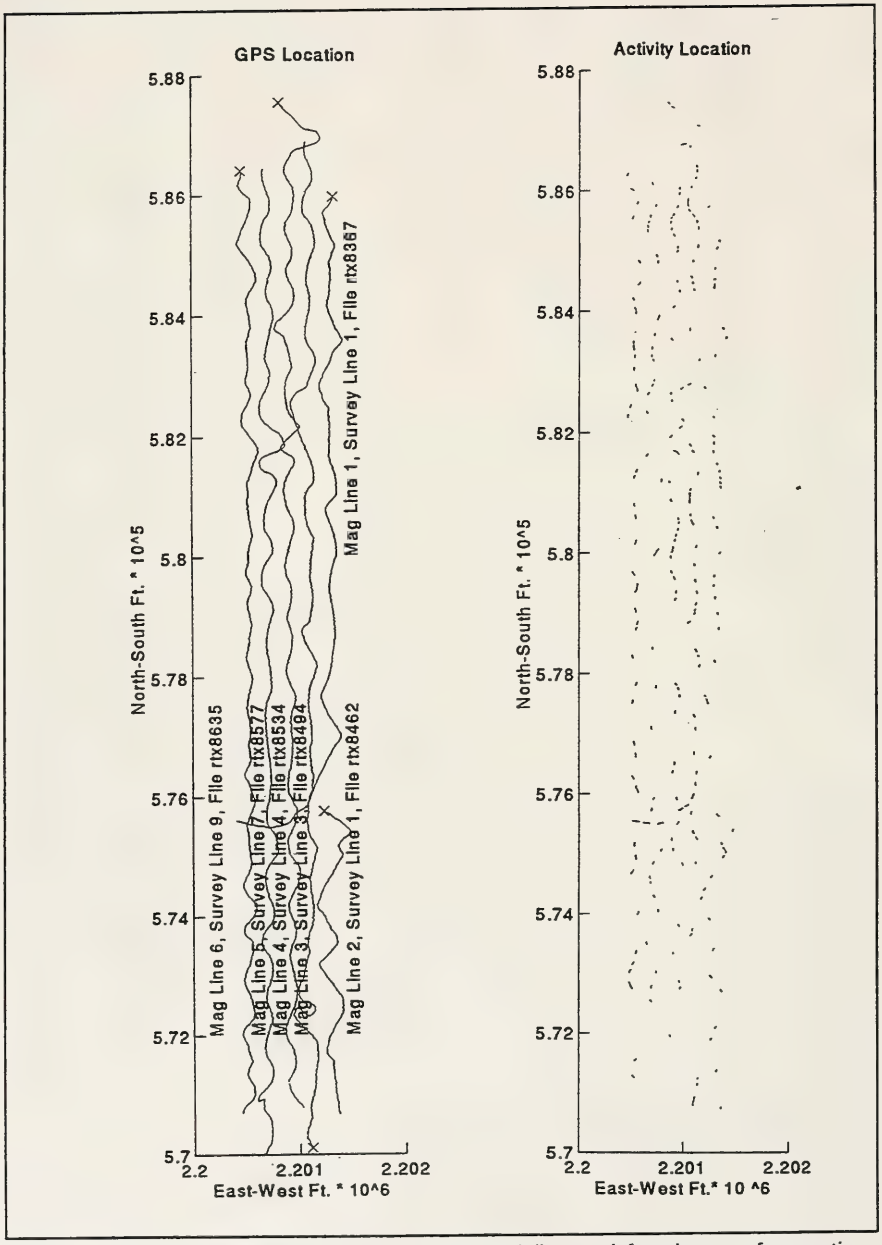
Significant concentrations of ordnance-sized objects were encountered throughout these passes. The spatial distributions of magnetic responses along the traverses are shown in Figure 18. Areas along the line where a magnetic response was evident are darkened. This practice shows any two-dimensional distribution of ferrous objects in the investigated area and allows for discrimination of larger versus smaller objects. The transverse magnetic gradient of each of the long track lines is displayed in Figures 19 through 27. A positive gradient anomaly in these figures represents a magnetic object east of the line, while a negative response indicates an object west of the line. A larger object will have a longer segment of the line where a magnetic disturbance is recorded. Evidence suggests that the density of magnetic objects diminishes at the southern end of the surveyed area.

Figure 18. Plot of long magnetic traverses showing truck lines on left and zones of magnetic response on the right. Scales are in feet measured from arbitrary zero points - locations do not represent State Plane coordinates

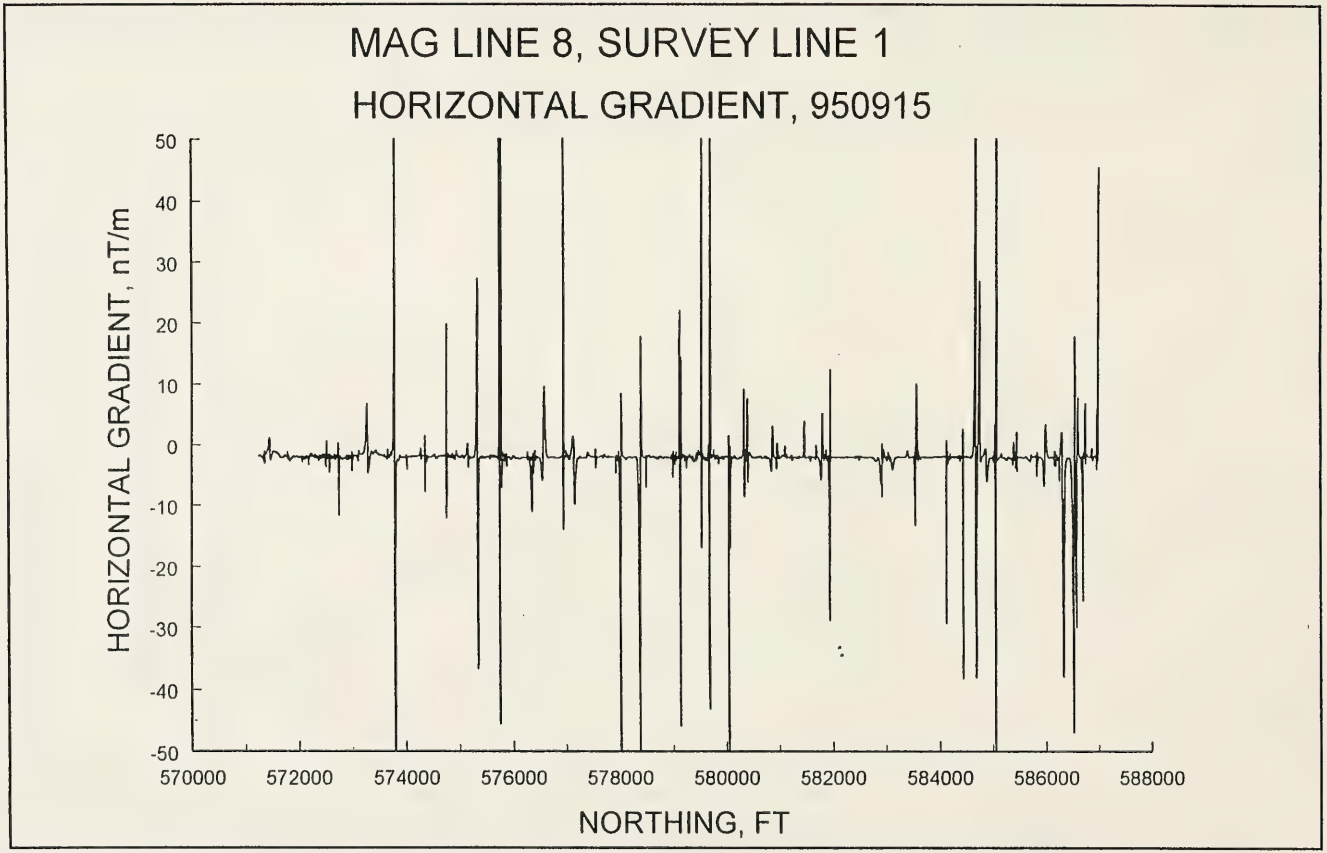
Figure 19. Horizontal gradient recorded on long magnetic traverse number 8. X-axis represents State Plane coordinate

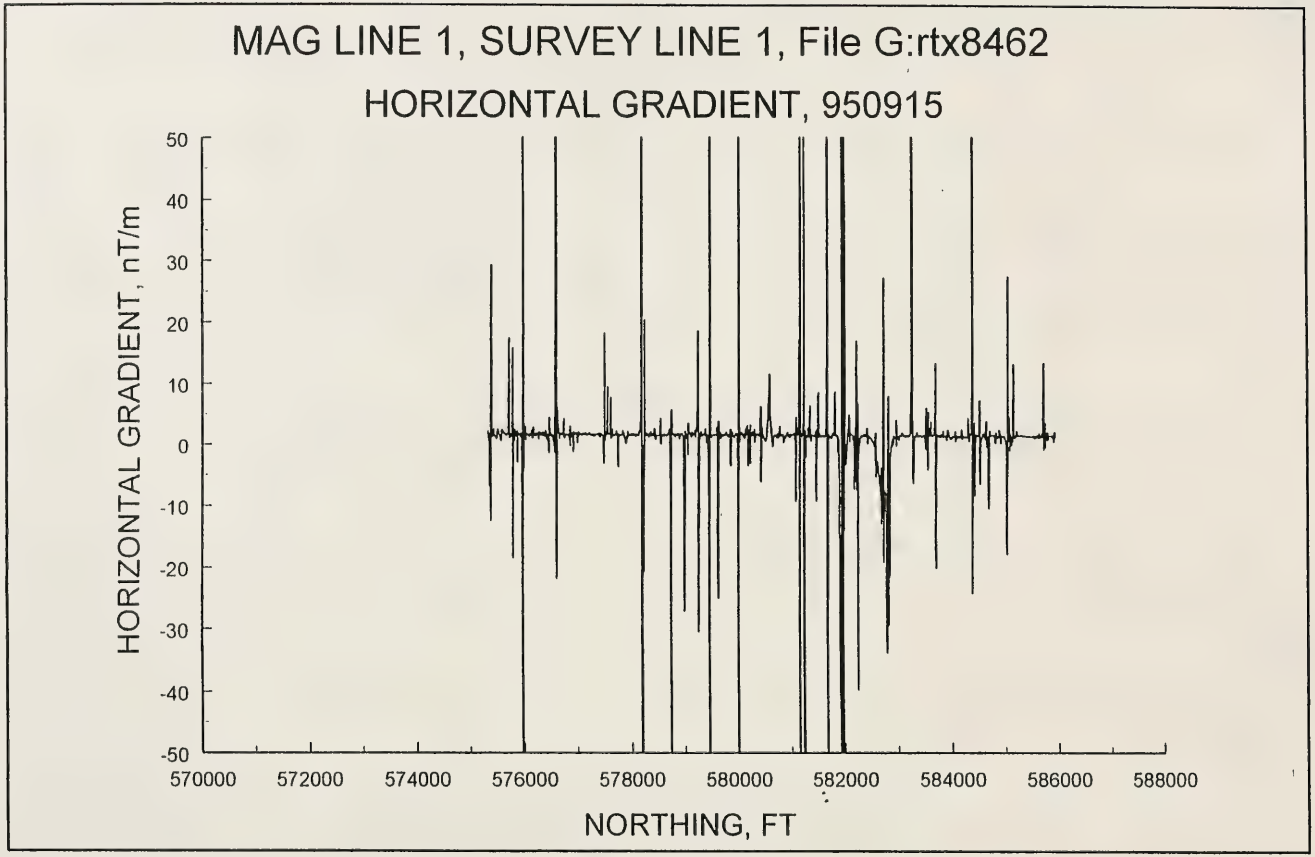
Figure 20. Horizontal gradient recorded on long magnetic line number 1. X-axis represents State Plane coordinate

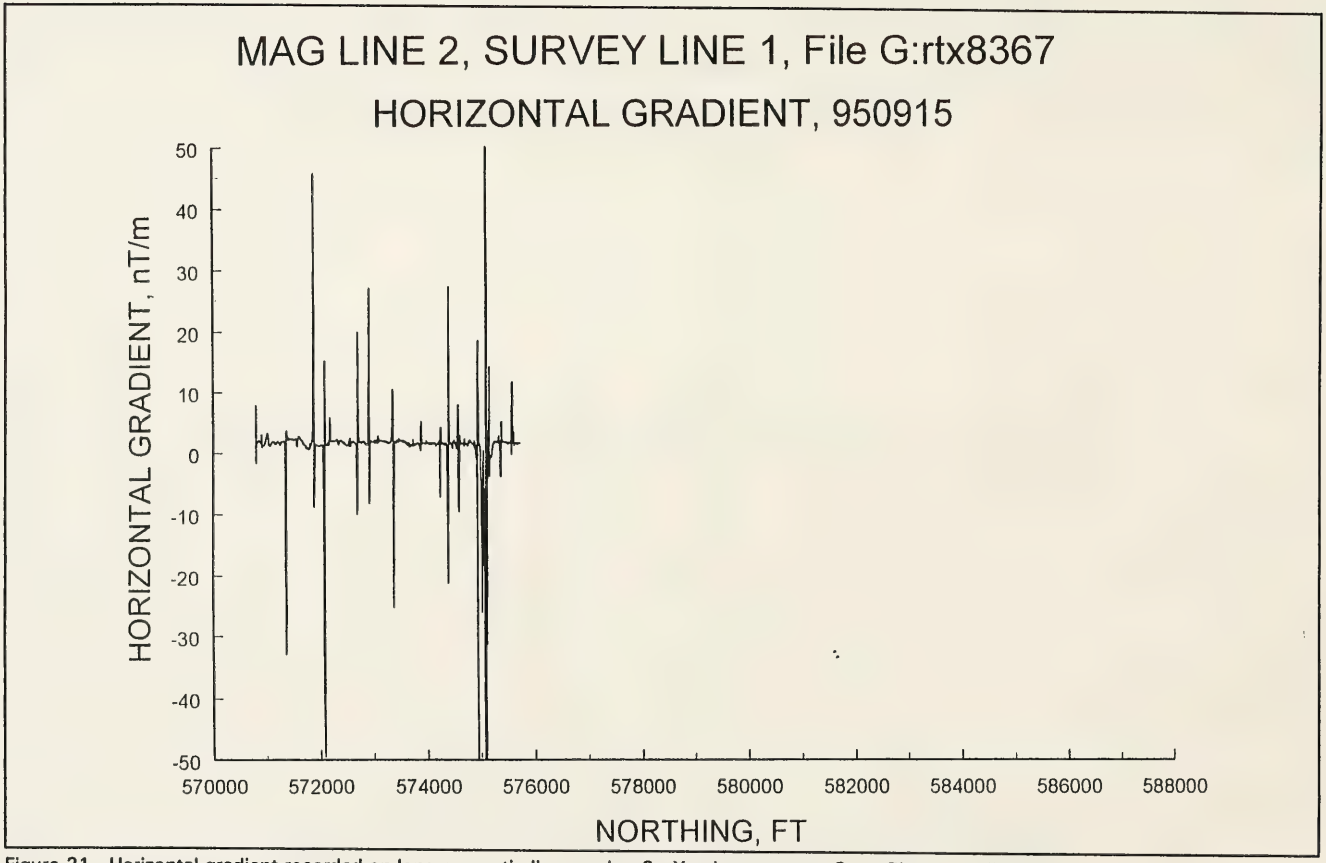
Figure 21. Horizontal gradient recorded on long magnetic line number 2. X-axis represents State Plane coordinate

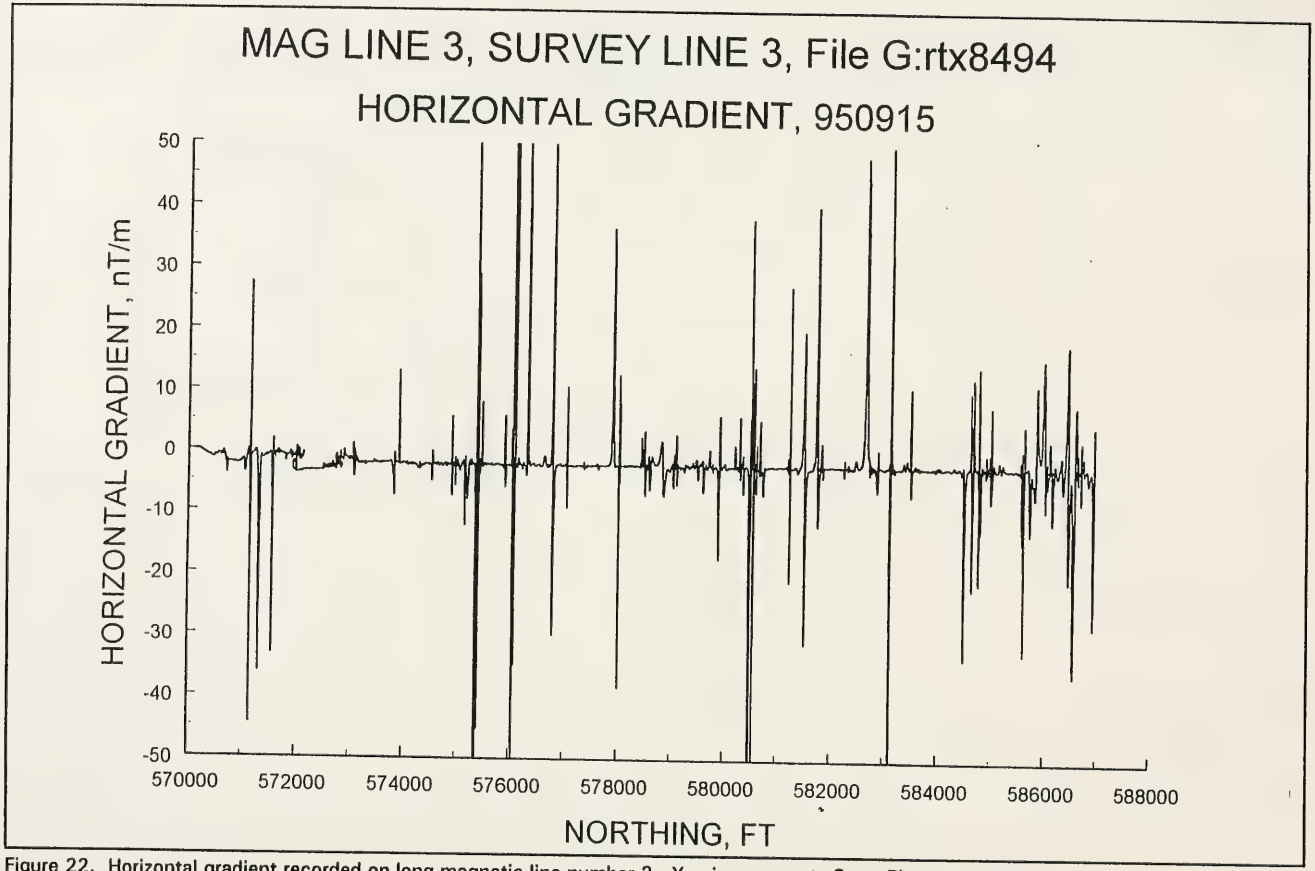
Figure 22. Horizontal gradient recorded on long magnetic line number 3. X-axis represents State Plane coordinate

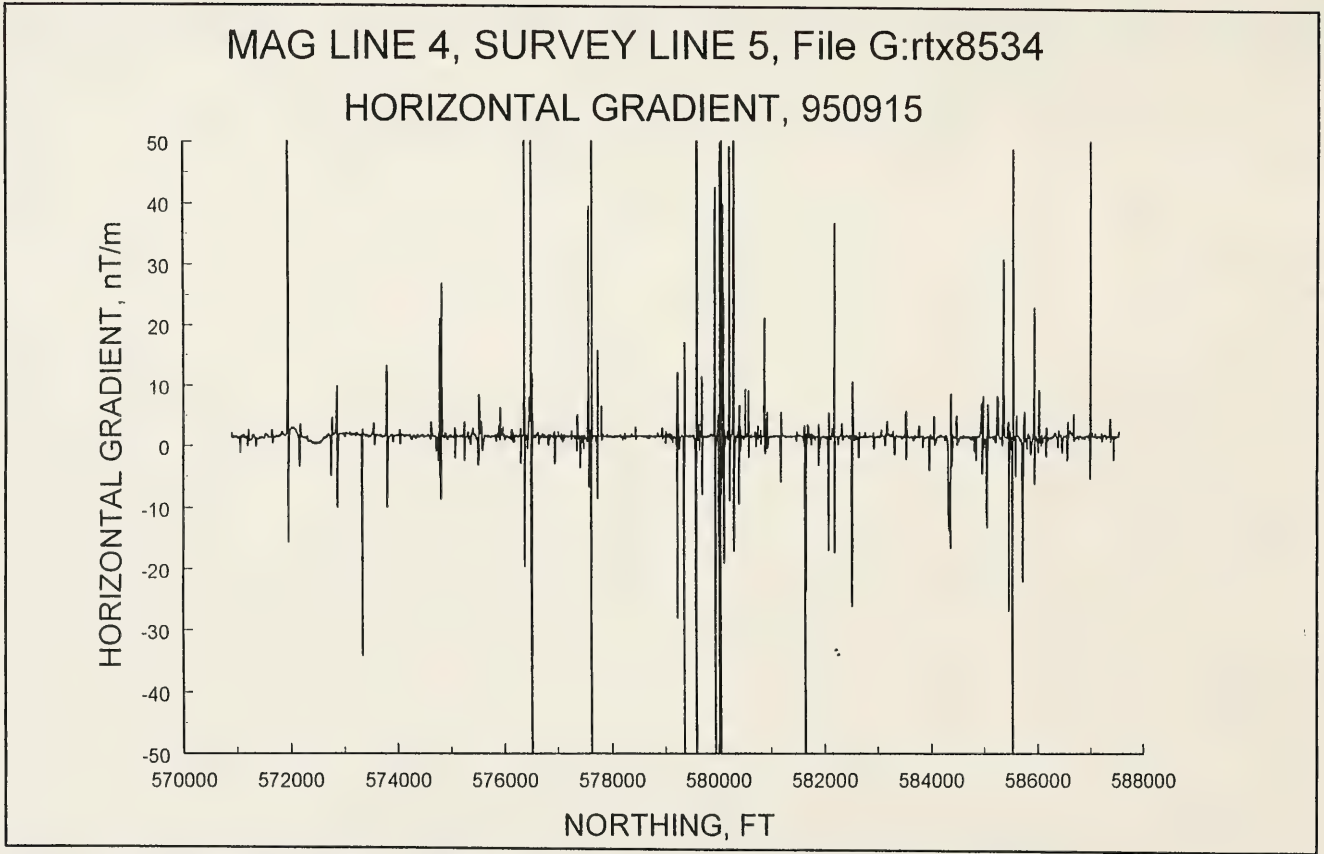
Figure 23. Horizontal gradient recorded on long magnetic line number 4. X-axis represents State Plane coordinate

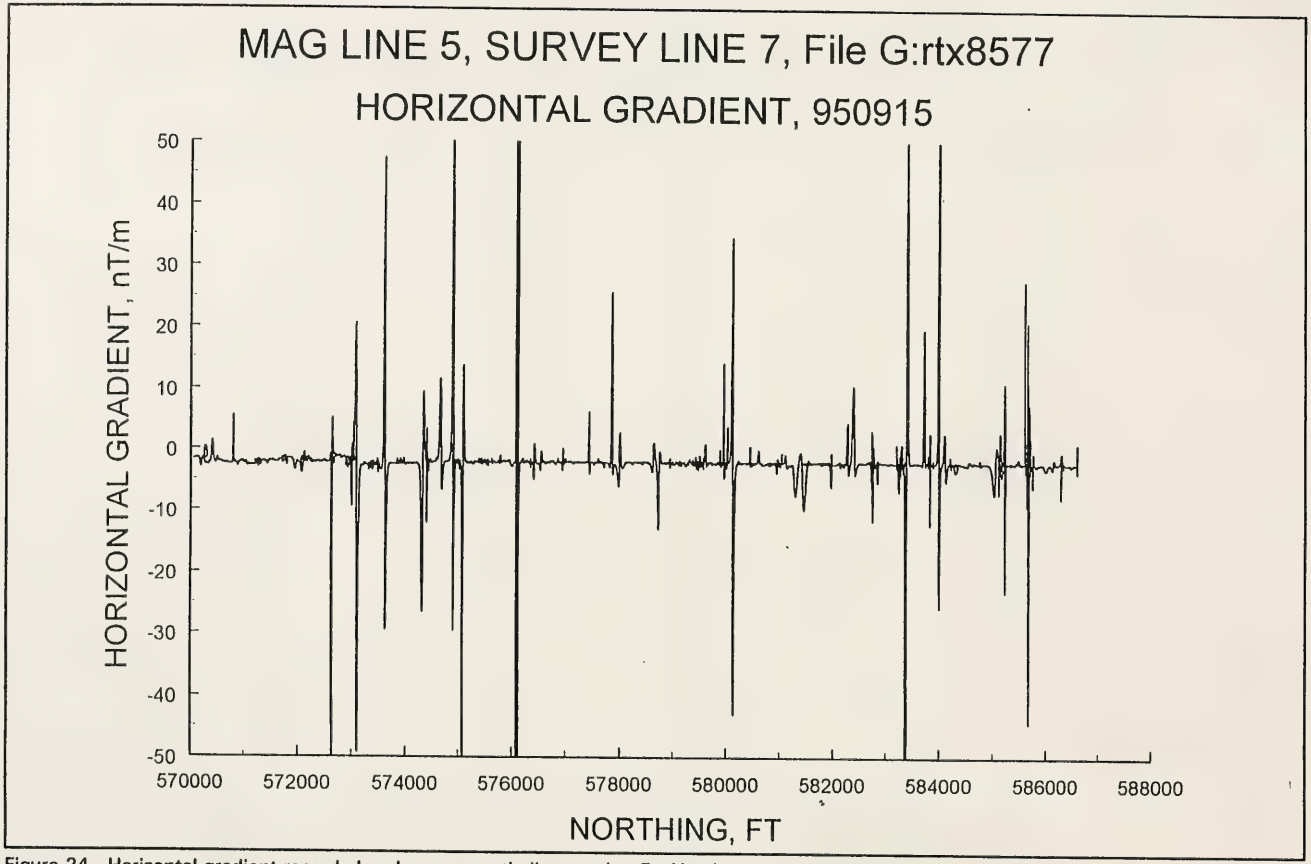
Figure 24. Horizontal gradient recorded on long magnetic line number 5. X-axis represents State Plane coordinate

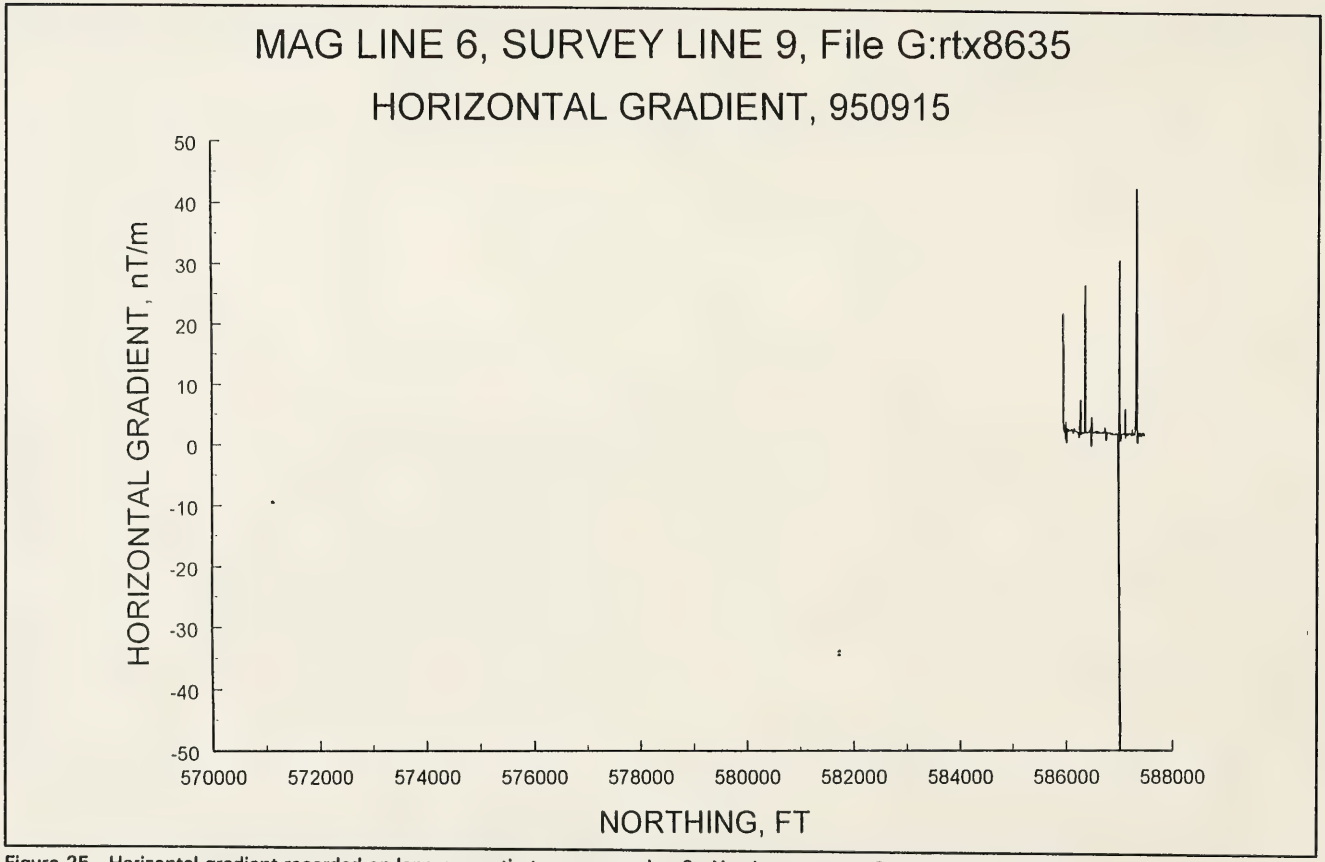
Figure 25. Horizontal gradient recorded on long magnetic traverse number 6. X-axis represents State Plane coordinate

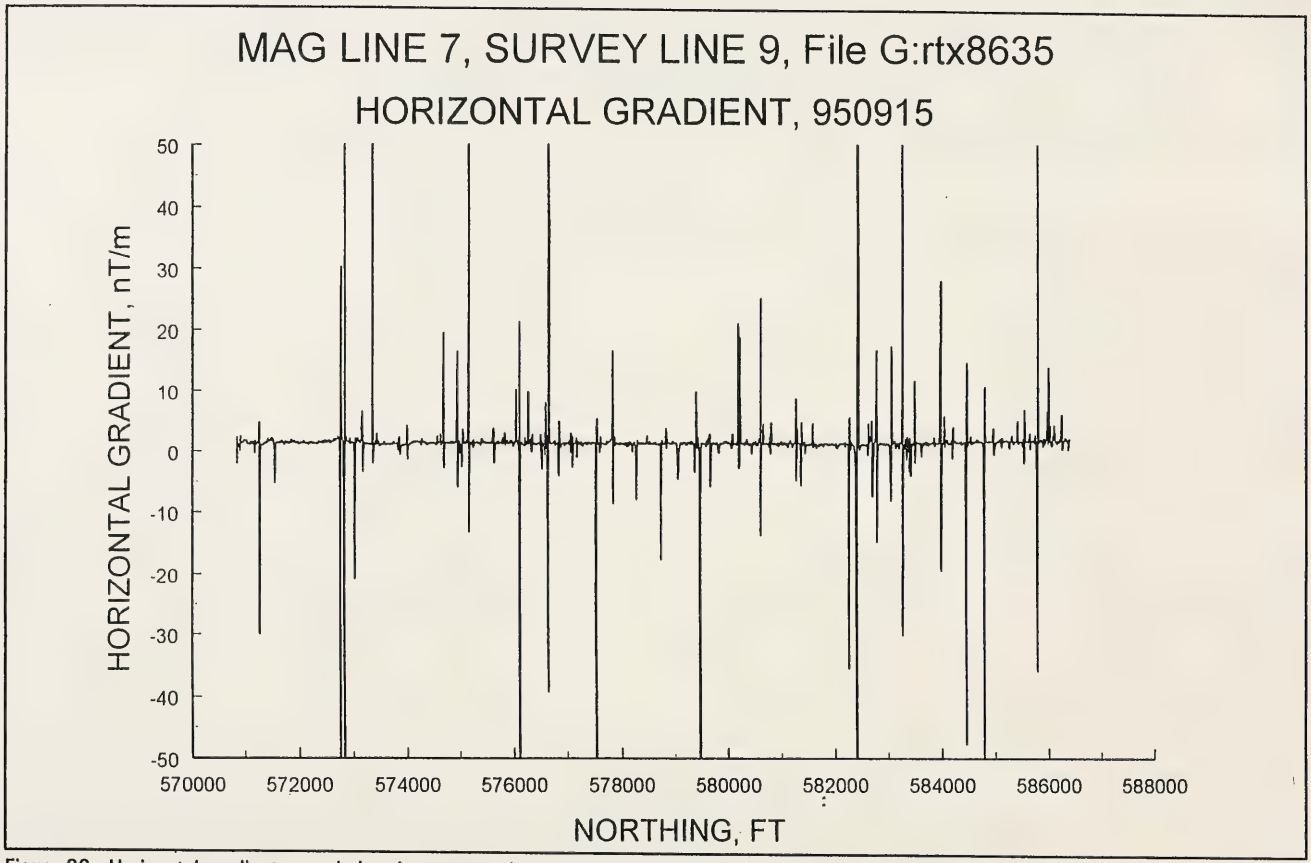
Figure 26. Horizontal gradient recorded on long magnetic traverse number 7. X-axis represents State Plane coordinate

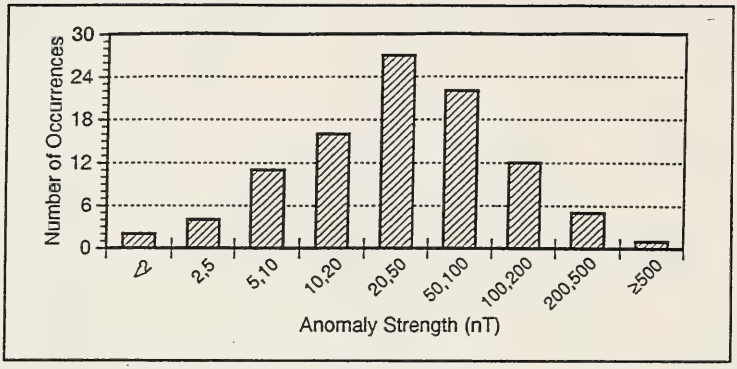
Figure 28. Anomaly strength (peak signal magnitude) of 100 samples selected from the north-south magnetometer lines. (Plot provided by AETC)

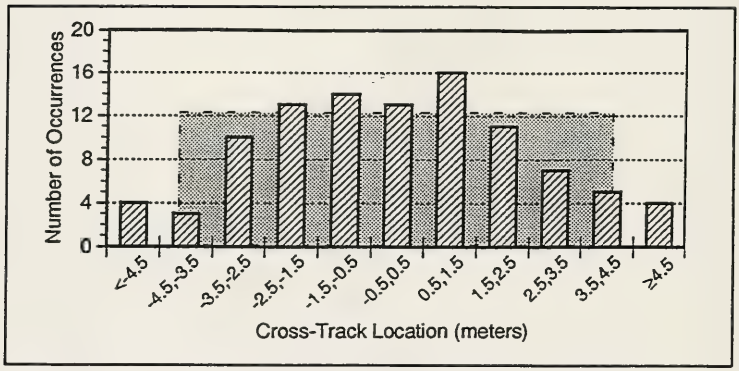
Figure 29. Cross-track locations, 100 analyzed samples. Shaded area indicates computed detection range of array used in the field. (Plot provided by AETC)

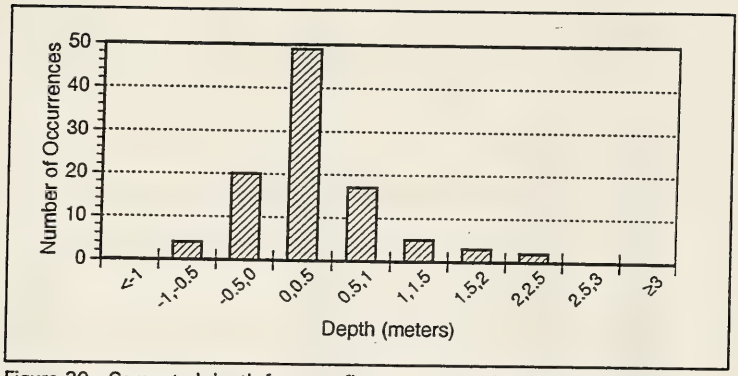
A total of 240 anomalies were counted by AETC during their analyses. Assuming that all the anomalies correspond to targets and that the detection swath is 4 m to either side of the track, this amounts to an ordnance density of about 15.4 objects per hectare. The raking operation recovered ordnance at only one tenth of this density, about 1.3 objects per hectare. The discrepancy may be due to three factors. First, not all anomalies may be caused by actual ordnance but rather by other sorts of metallic debris. This, however, is not likely to be significant due to the average precision of fit which exceeded 0.98 of the measured magnetic anomalies to simple dipole models. Most marine debris would not be representative of simple dipole magnetic sources. Second, the raking operation may have failed to recover many ordnance items on the sea-floor. Preliminary tests in other locations have shown that many shells fall out of the rakes before they can be retrieved onto the deck of the vessel. Also, a factor due to the raking activity occurred in Borrow area 1A, which is seaward of the area evaluated by AETC. Most likely the difference is from the shallow depth (10 cm) that the *Miss Kathy* was able to reach. Analysis of the depth of the ordnance, Figure 29, shows that most of the ordnance is below 10 cm in the sand, but buried shallower than 1.5 m.

Figure 30. Computed depth from seafloor to center of objects. Negative values correspond to dipole fits where the center of object is above the bottom. Most objects are lying on the seafloor. (Plot provided by AETC)

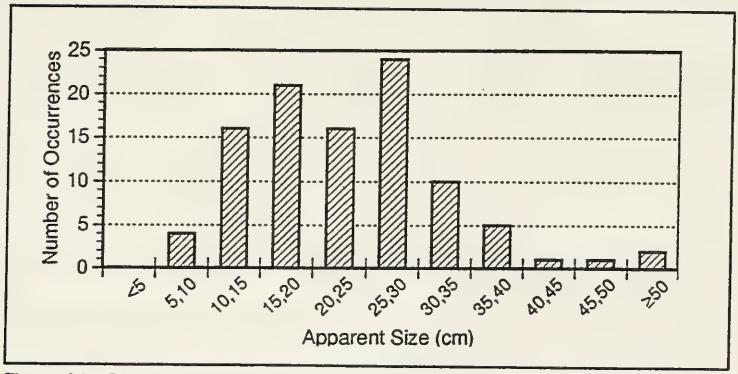
Finally, Figure 31 shows the distribution of apparent sizes of the anomalies. The apparent size of an object is its equivalent radius, which is the radius of a steel ball having the same dipole moment. Bell, DeProspo, and Prouty (1996) found that ordnance caliber is almost equal to the measured dipole radius. Figure 31 also shows that objects range from 5 to 50 cm, with the most common clustering between 10 and 35 cm (4 to 14 in.). These sizes are consistent with the caliber of ordnance recovered in the test raking operation by the *Miss Kathy*, but the distribution is different. The distribution of the raked ordnance was dominated by smaller pieces (*i.e.*, 8- to 13-cm range), and the raking operation only recovered 24 objects, a sample size too small to use to evaluate the distribution of size classes (Figure 32).

Figure 31. Distribution of apparent sizes of the 100 test objects. (Plot provided by AETC)

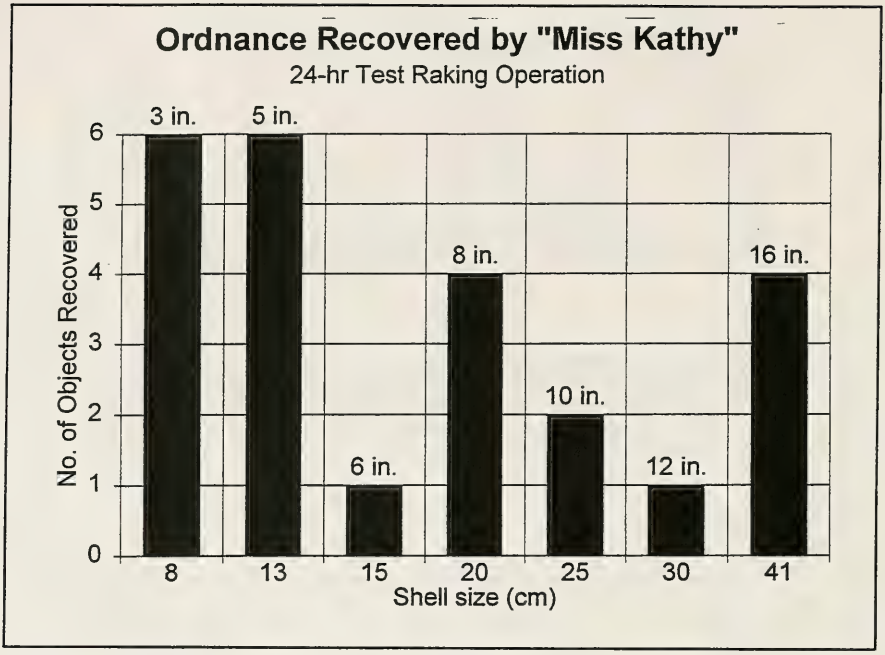
Figure 32. Distribution of sizes of ordnance recovered during 24-hr test raking operation
